60X 85 American Pluverizer serial number 8396 Shredder installed 2001 evaluation report

Rifkin Scrap Iron and Metal 1445 North Niagara Street Saginaw, MI 48602 Office 1-989-752-7646

Wendt Corporation
Jim Armstrong
Rotor and casting specialist
Office 1-716-391-1223
Cell 1-716-622-1393
Date of evaluation: 9-2-15

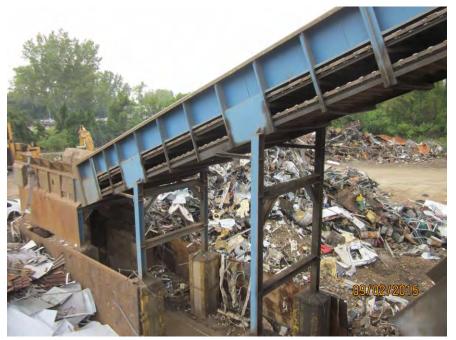
Main Structural Support in good condition. No major material trapped on belt

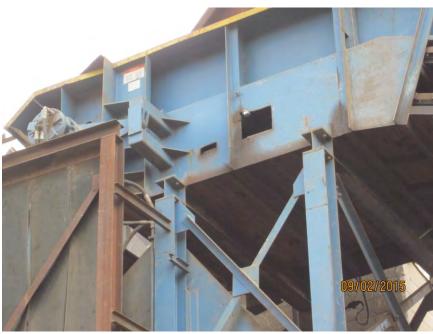
Hydraulic motor drive pulley clean and free of hydraulic leaks head shaft in good condition

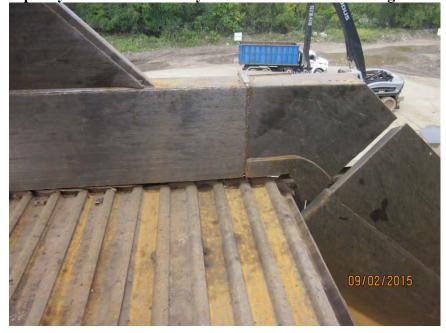
Transition from Infeed Conveyor to chute excellent condition. Side walls great condition.

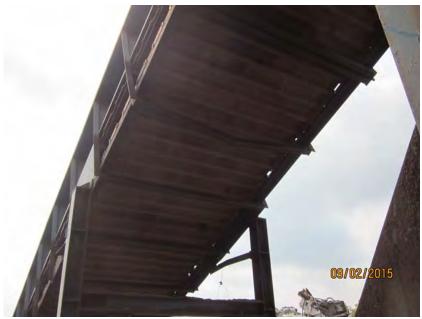
Structural frame work in good shape under the main frame

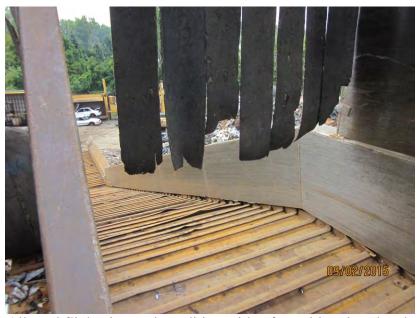
All steel flights in good condition with a few with minor bends

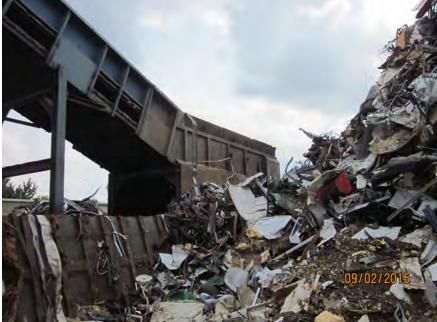
Load section and tail pulley in good condition clear from debris and tail pillow blocks covered with shield

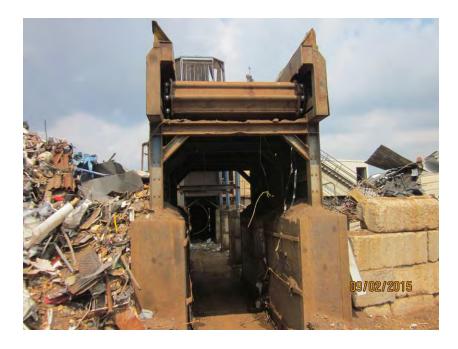
Tail shaft pulley and tail shaft pillow block bearing in good condition

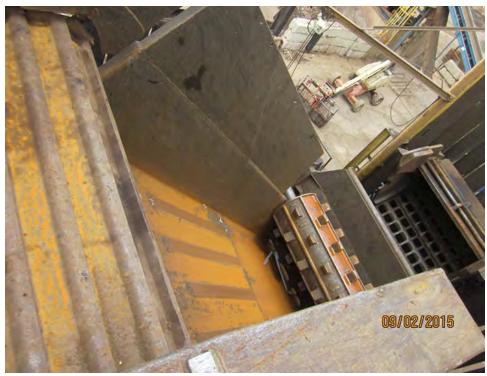
Main floor and side walls in excellent condition with new installed wear strips

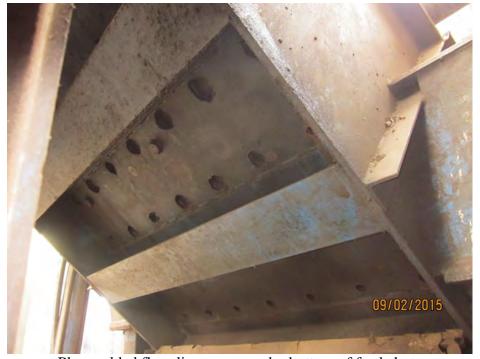
Plug welded floor liners seen under bottom of feed chute

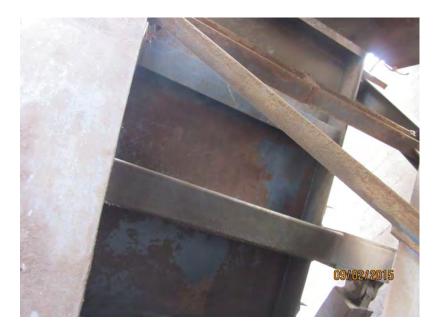
Bottom of chute fabrication in good solid welded condition

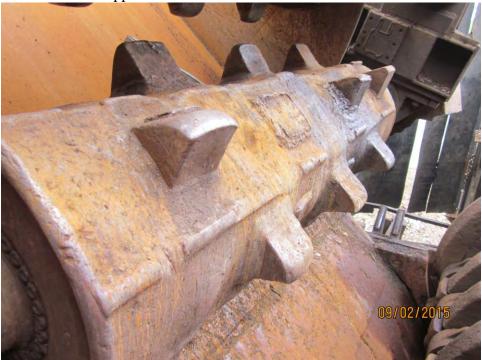
Lower feed roll drum couple teeth missing should be replace. Drum in good condition

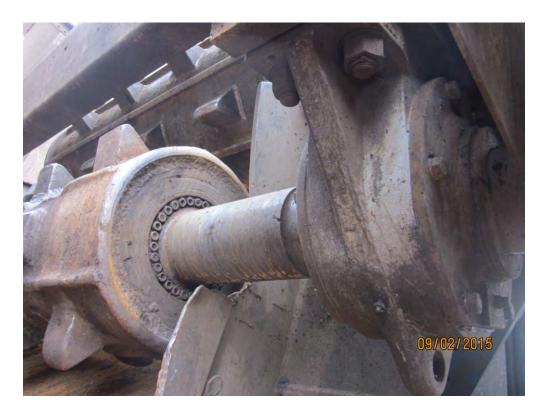
No wire wrap around end of feed roll drum shafts with no evidence of the shafts being gouged from a cutting torch

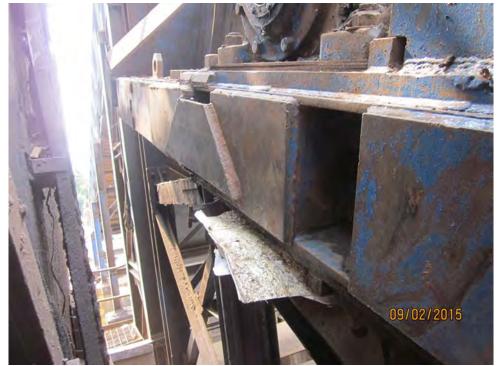
Feed roll frame in good condition straight with no evident weld cracking or twisting

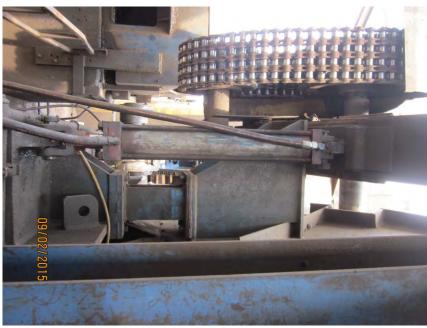
Feed roll drum chain drive, sprockets and chain in great condition. No hydraulic leaks from drive motor or feed roll hydraulic lift cylinder(Photo rotated 90 degrees)

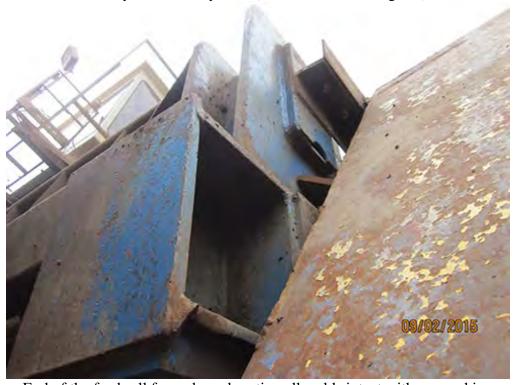
End of the feed roll frame boxed section all welds intact with no cracking

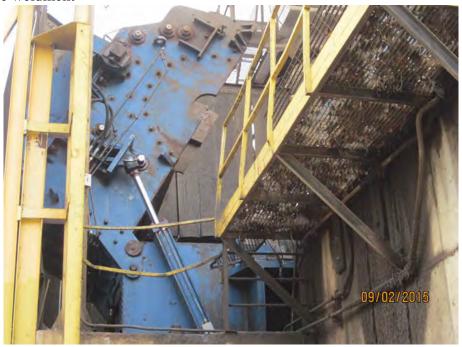
Mid-section hydraulic lift cylinder in excellent condition. No leaks and pivot pins in great condition.

Bent side wall needs repaired

Example the mid-section wall bent will need to heated and pulled back into position.

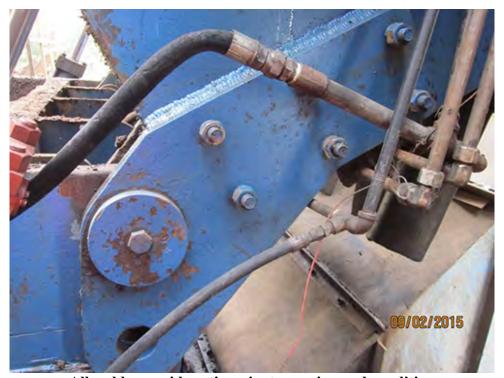
All welds on mid-section pivot arms in good condition

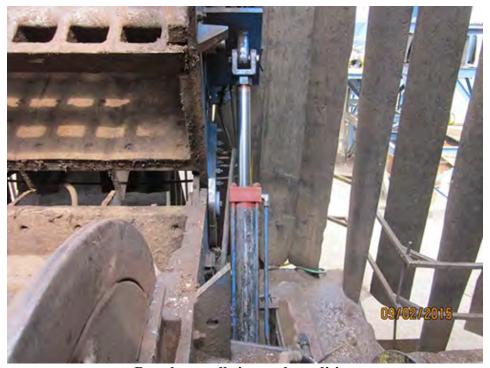
Base box walls in good condition

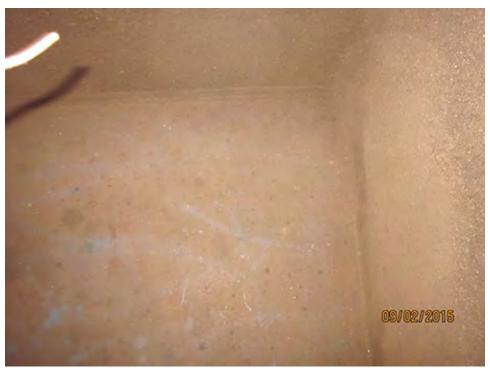
Base weld gussets no cracks evident in excellent condition

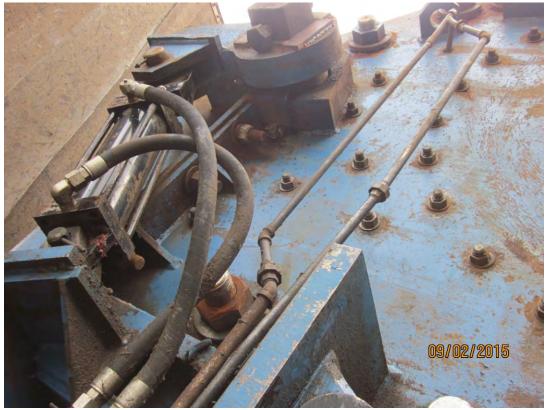
Reject door fabrications and reject door casting pivot attachment in excellent condition . No hydraulic leaks in cylinder

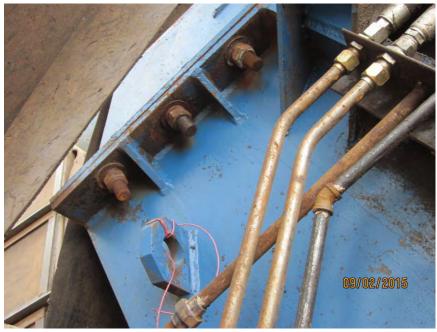
Bonnet or deflector top tight to the mid-section

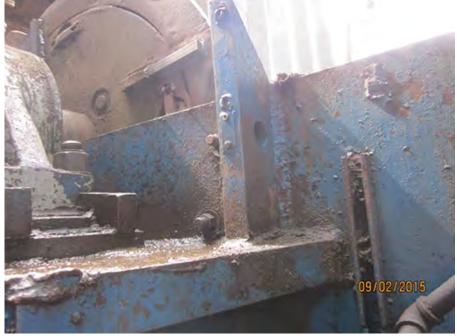
Bearing pedestals in good condition with no evidence of weld repair to the base

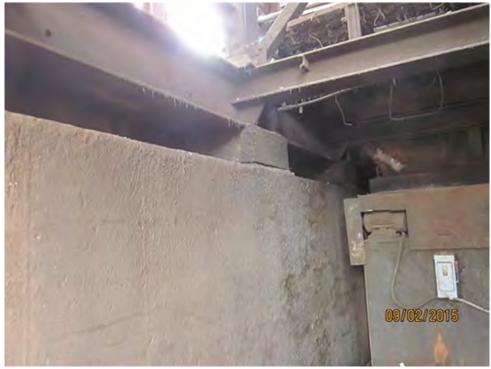
The shredder box springs appear in great condition and functional

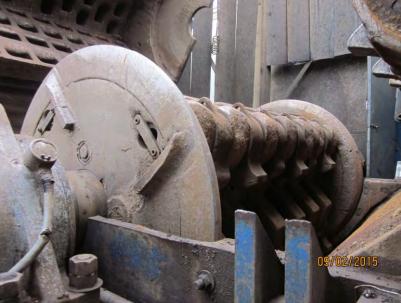
Rotor in good condition 280,00 input tons. Tight to main rotor shaft. Tie rods look like there has been a repair.

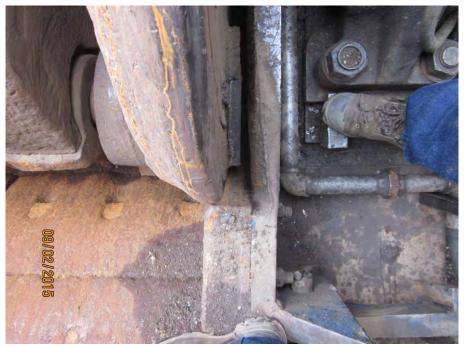
End discs caps need to be replaced extreme wash from the material impacting the end disc face. Side chute entrance liners should be replace and for additional protection.

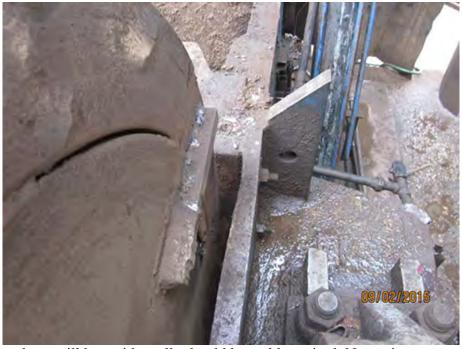
Small amount of wash on mill base side walls should be weld repaired. New wipers on rotor disc have been added that will help this condition.

Welding of the base were the rotor end disc is causing wear to the side walls.

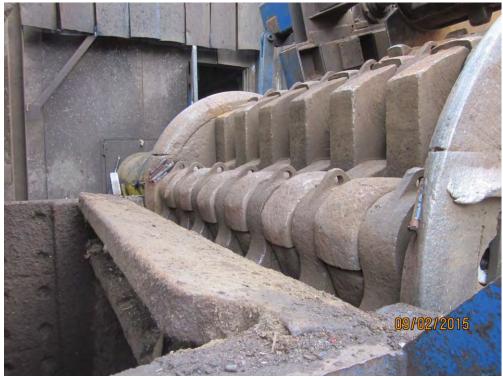
Welded round stock has been added for protecting the cap from hammer wash.

They will not last for any length of time as the caps should be replaced

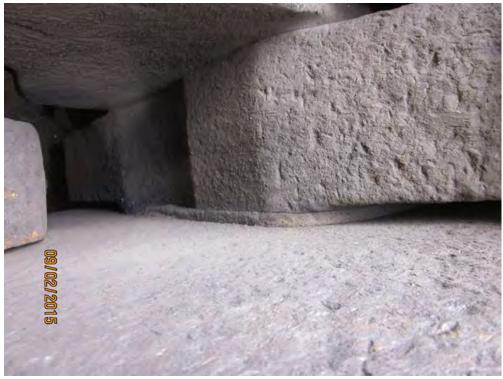
Weld repair has been added to the spider arm. This tells me the rotor stack is not tight and will only keep the rotor together for a shorter period of time.

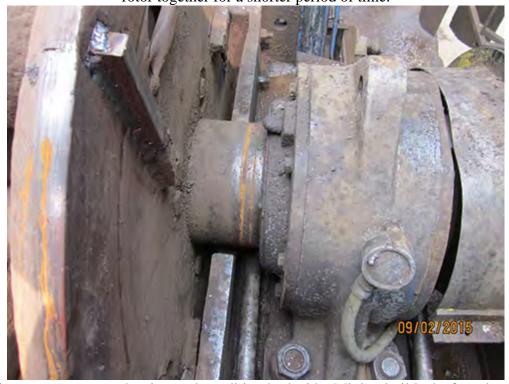
Bearing temperature probes in good condition both side. Minimal oil leaks from bearings.

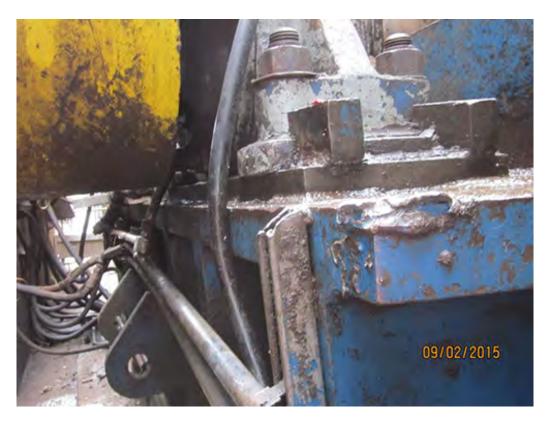
Bearing shim plate have been welded to shredder pedestals bearing stop blocks are welded permanent. This could be additional work if the bearing needs replaced or a broken rotor tie rod needs replace.

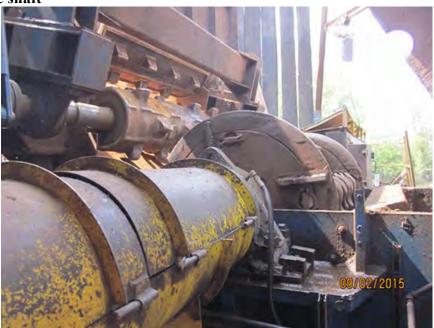
Safety cover excellent condition

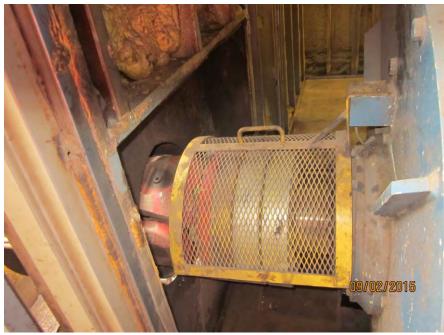
Motor coupling end with guard excellent condition

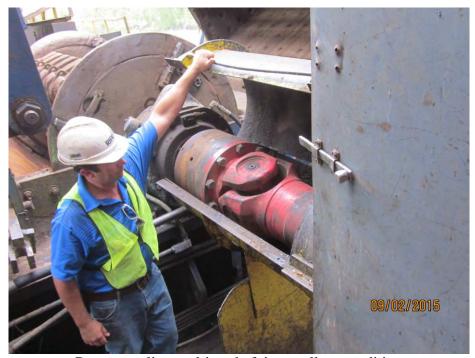
Rotor coupling to drive shaft in excellent condition

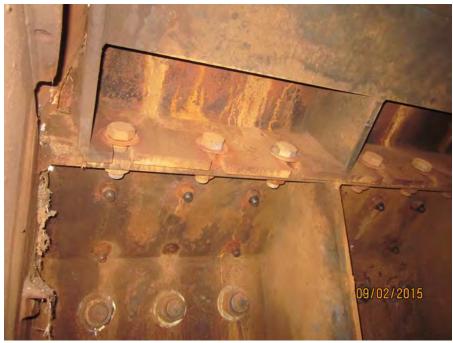
Casting anvil bolts from back side of Mill base under chute are all tight and have not moved All surface welds appear in good condition on anvil seat.

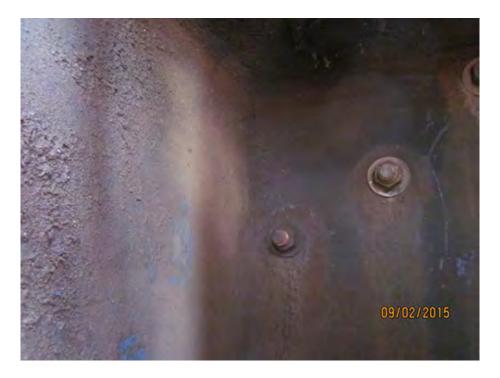
Base section side liner bolts are tight and show no movement

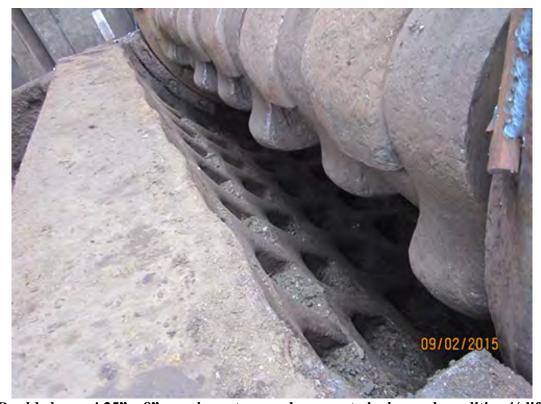
Double beam 4.25" x 8" openings staggered appear to be in good condition ½ life

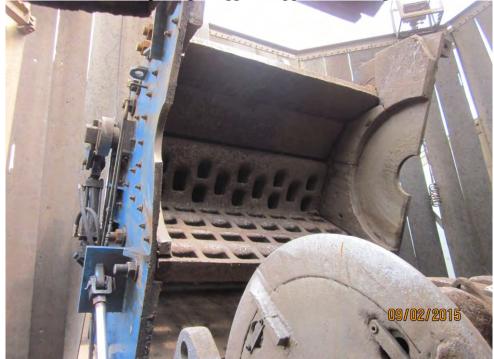
Reject door front wall liners and side wall liners appear in good condition.

Minimal wash on side wall track facing rotor end discs.

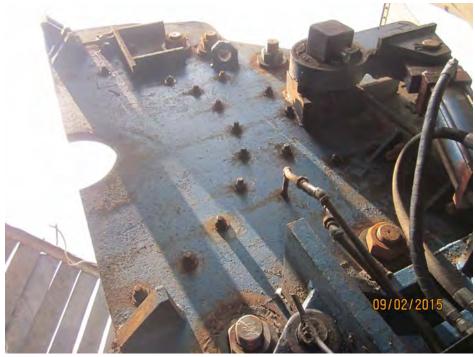
Upper mid-section liner bolts in good condition with no movement observed.

Holes in mid-section walls for liners in great condition.

Front wall tie rods in excellent condition with weld repair to the box side walls and the installation of steel bushings.

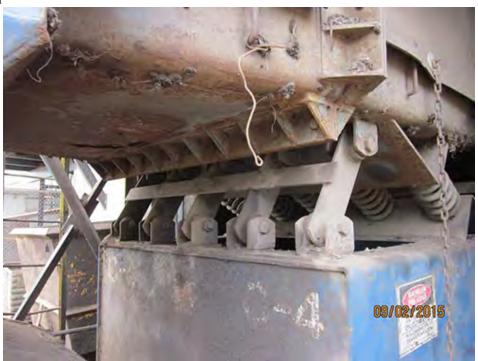
Exit trough pan has rust thru occurring

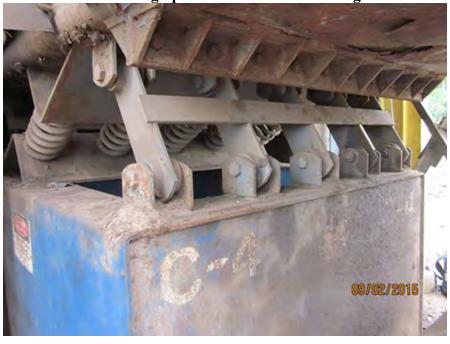
Actuating arms in good condition

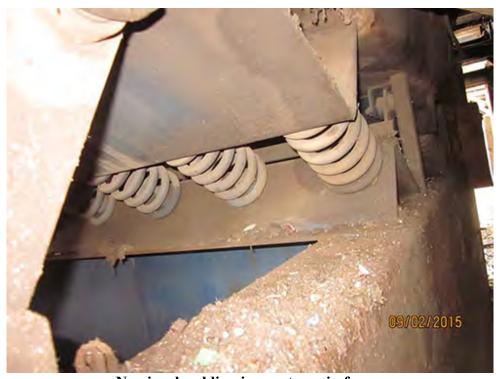
No visual welding issues to main frame

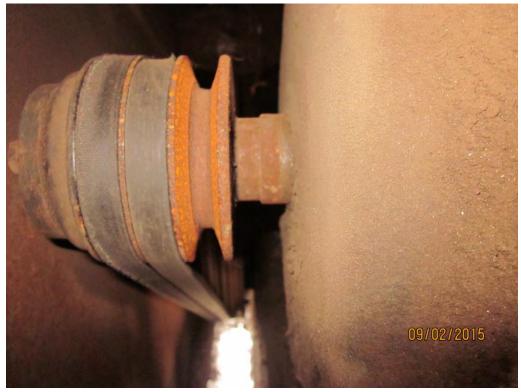
Pulley belt missing that drives the eccentric

Pulley belt replacement on the under mill feeder.

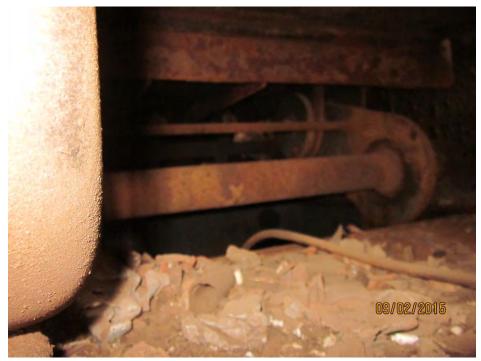
Conciderable rust on eccentric drive shaft. Cover should be removed and greased

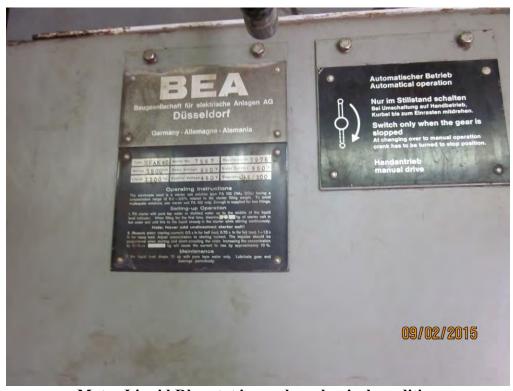
Motor Liquid Rheostat in good mechanical condition
