60X 85 American Pluverizer serial number 8396 Shredder installed 2001 evaluation report

Rifkin Scrap Iron and Metal 1445 North Niagara Street Saginaw, MI 48602 Office 1-989-752-7646

Wendt Corporation
Jim Armstrong
Rotor and casting specialist
Office 1-716-391-1223
Cell 1-716-622-1393
Date of evaluation: 9-2-15

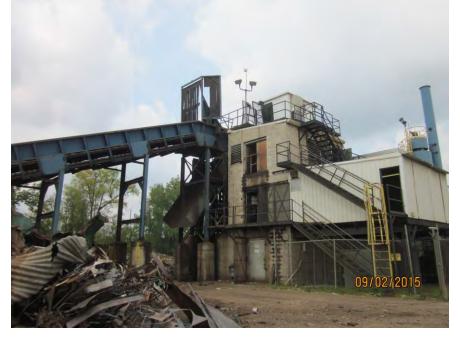
Main Structural Support in good condition. No major material trapped on belt

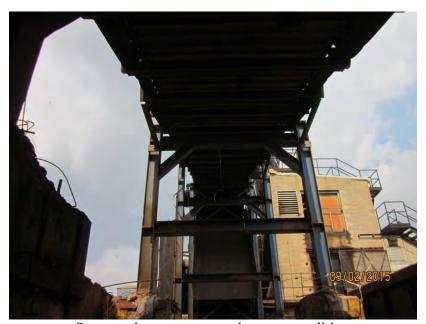
All steel flights in good condition with a few with minor bends

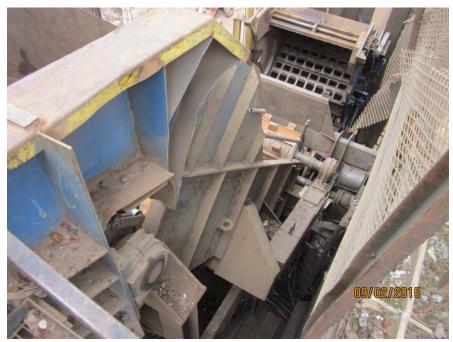
Outside walls of chute in excellent shape and straight

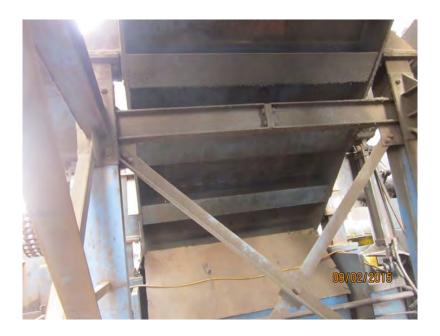
Bottom of feed chute full view

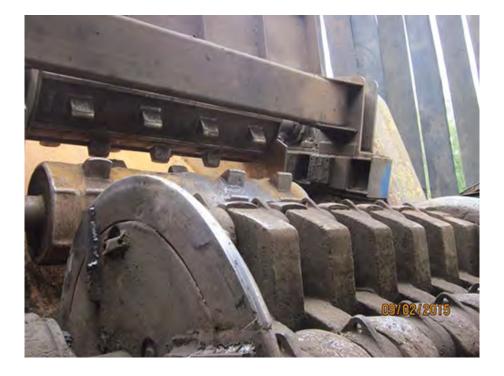
Feed roll frame rectangular cross member torque tube in great shape more robust fabrication added by customer

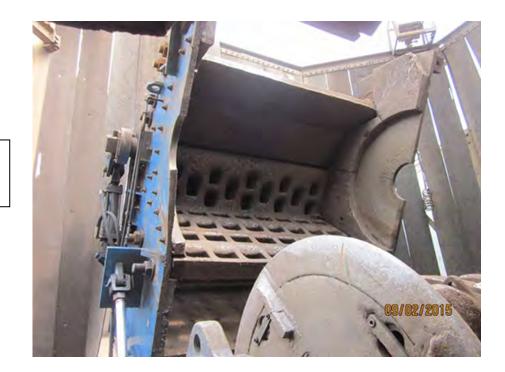
Bent side wall needs repaired

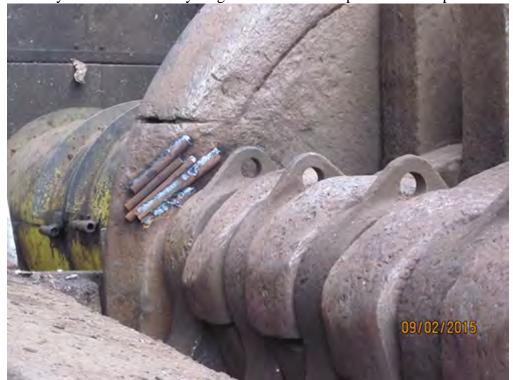
Welded round stock has been added for protecting the cap from hammer wash.

They will not last for any length of time as the caps should be replaced

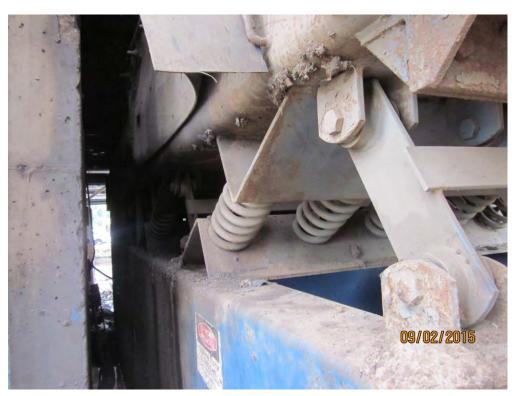
Pulley belt missing that drives the eccentric

Pulley belt replacement on the under mill feeder.

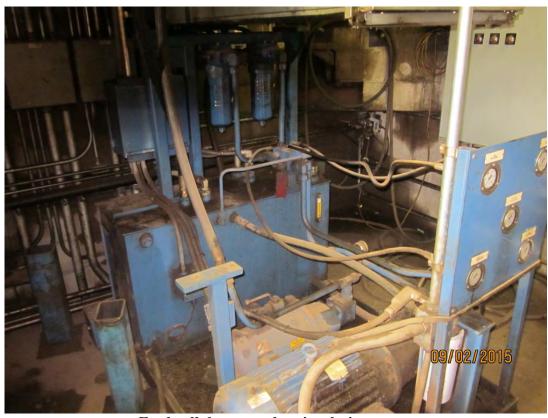
Feed roll drums and recirculating pump
All hydraulic tanks in great condition free of hydraulic leeks and new filters installed
All oil under pumps dry and clean

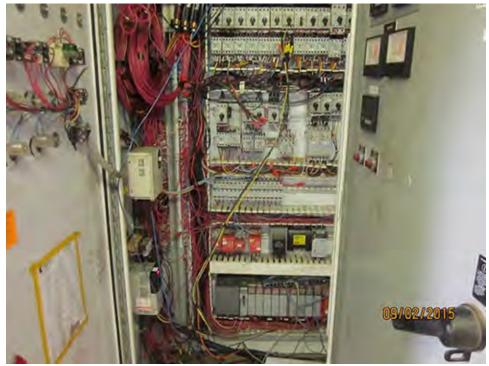
Lose wiring needs to be reinstalled back into wire ways

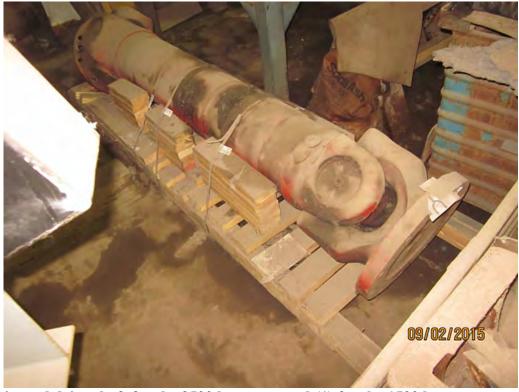
(2) Universal drive shaft for the 2500 hp motor and (1) for the 1500 hp motor not shown
